## Performance Analysis of Medium Voltage Porcelain and Polymer Cut-out Fuse Insulators under Lightning Impulse Wave Forms

*Foundation University Islamabad*

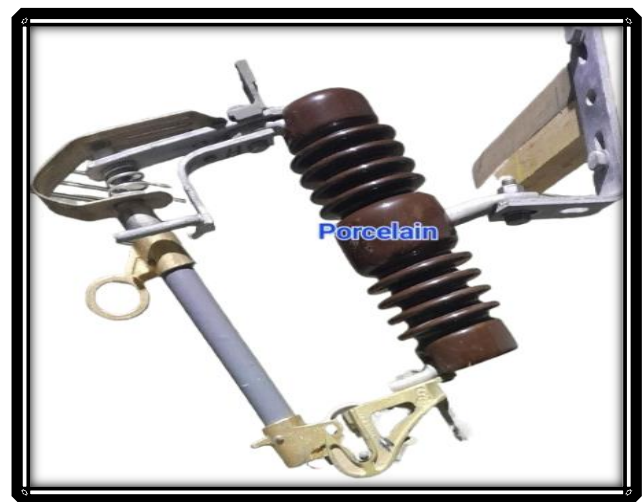
**Fig. 2.** Porcelain Cutout Fuse Insulator

The diagram shows their installation on cross arms, with impulses applied to the upper terminal, and the support base is grounded. For porcelain insulators

(Figure 1) and polymer insulators (Figure 2), the dry arcing distances are 180 mm and 240 mm, respectively, with a design voltage of 15 kV.

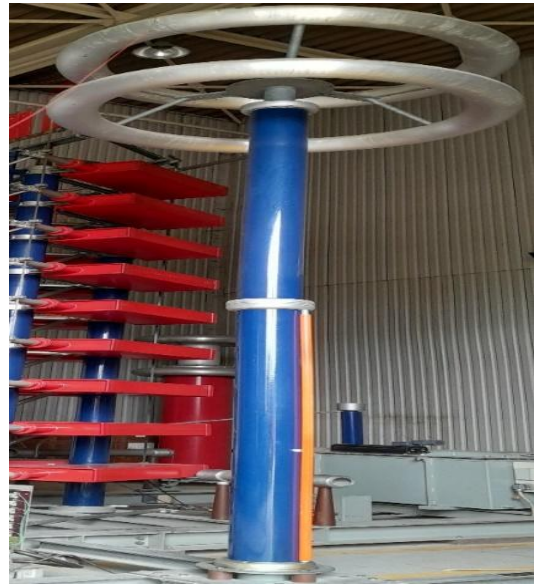
An indoor type divider is utilized, with "Shell Diola C" oil serving as the insulating oil, having a freezing point of  $-40^\circ\text{C}$ . The high voltage section of this divider comprises the C1 capacitor and the R1 resistor connected in series, which is shown in Figure 7.

The high voltage section of the divider allows for flexibility in determining the capacitance value, denoted as  $C_1$ , within defined boundaries. The minimum value is determined by the stray capacitance, typically around 50 pF/m, while both the efficiency factor and the shape of the impulse waveform influence the upper limit. The high-voltage resistance ranges from approximately 100  $\Omega$  to 1500  $\Omega$ , with lower resistance values around 100  $\Omega$  to 300  $\Omega$ . In lightning impulse applications, the voltage divider serve as the fundamental load capacitance for the measurement system. Under these conditions, the time constant ( $R_1 \cdot C_1$ ) of the primary portion is recommended to lie within the range of 100 ns to 150 ns. When the damping resistance ( $R_1$ ) is increased, the voltage divider operates as a specialized measuring unit, particularly suitable for test specimens with low capacitance.

The low-voltage section of the divider comprises capacitor  $C_2$  and resistor  $R_{21}$  connected in series. If the time constant of the primary section is significantly shorter compared to the rise time being measured, the secondary resistance ( $R_{21}$ ) can be disregarded. Consequently, measurements are conducted primarily with the capacitive component, with the primary resistance ( $R_1$ ) serving as the damping resistor.

Fig. 7. Damp capacitive voltage divider

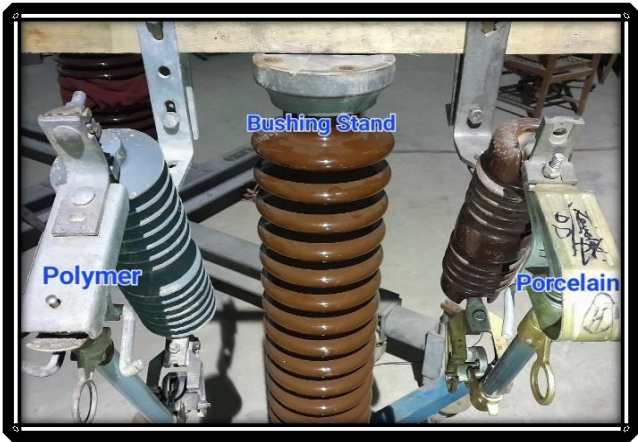
Fig. 8. Dry Polluted Specimens

The CFO of Insulators was estimated using the up-and-down method. All specimens were cleaned according to IEC 60507 standards before testing. Clean specimens were tested under dry conditions in a terminal-to-ground setup with a temperature of  $15.4^\circ\text{C}$ , 45.1% humidity, and 951.8mbar atmospheric pressure, with CFO voltages adjusted for standard conditions ( $20^\circ\text{C}$ , 11 g/m<sup>3</sup> humidity, 1013mbar pressure). Two specimens were heavily polluted using the dipping method, dried at room temperature for 24 hours (figure 8), and then placed in a fog chamber (figure 9) with fog introduced at a flow rate of one liter per hour. After 5-10 minutes, one insulator's surface became fully conductive, and flashover voltages with positive polarity were applied.
